## **UNDERWATER DIVING INSPECTION OF THREE WRECK-SHIPS AT ESTUARY OF THE RIVER BIMBIA TO THE TIKO PORT**

### **THE FIRST AND SECOND WRECK-SHIP**

**INSPECTION OF THREE WRECK-SHIP AT TIKO MAIN ENTRANCE TO THE PORT.**

## WRECK-SHIP ANALYSIS

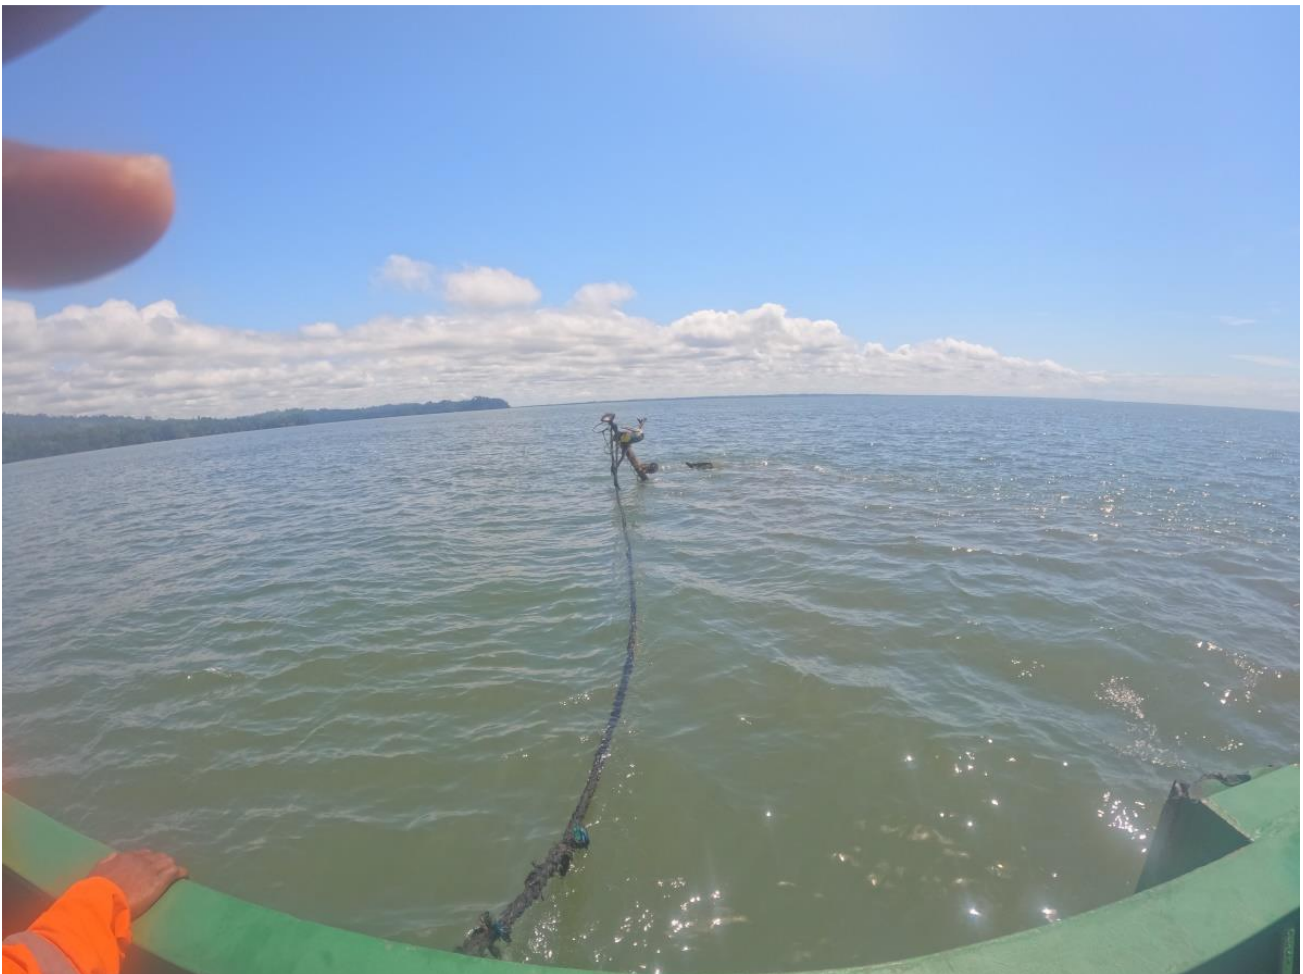
**LOCATION: WITHIN BIMBIA AND TIKO WATERS**

**THE FIRST WRECK-SHIP IS 85% SUNK BENEATH THE SEABERTH WHILE THE SECOND IS ON TOP OF THE FIRST.**

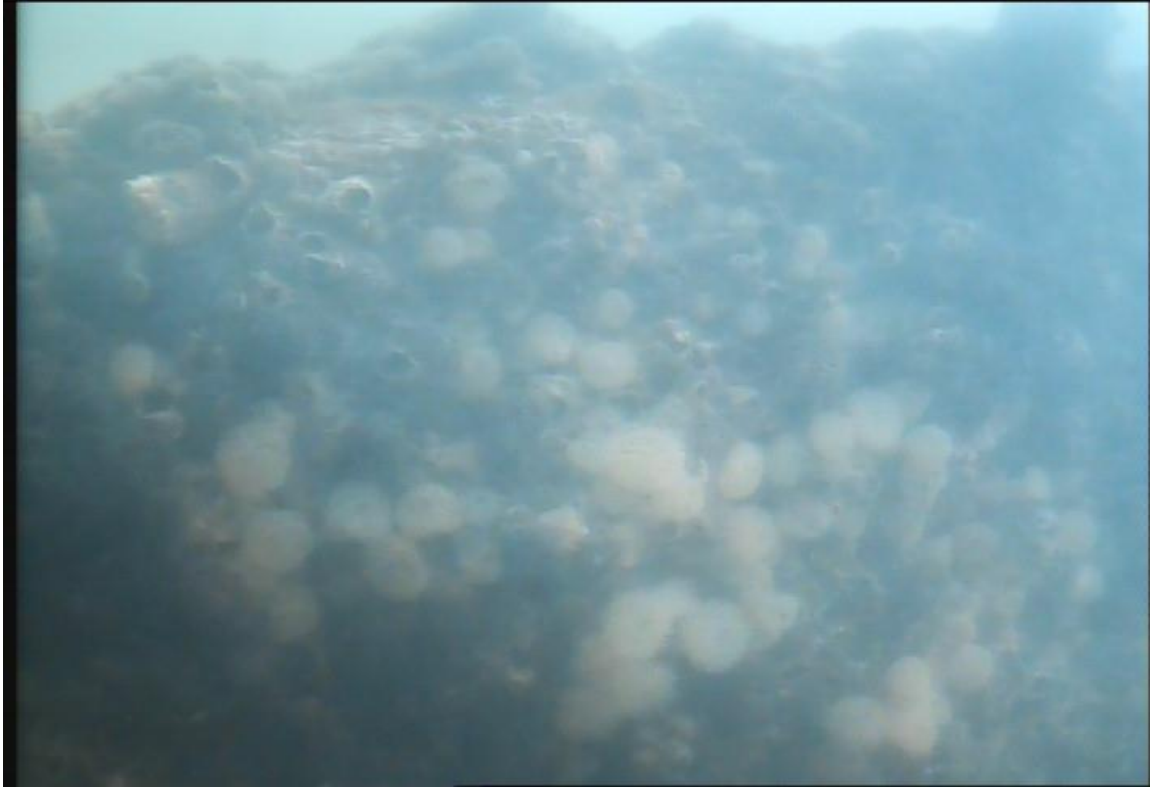
LOCATION	% AREA			SEVERITY	LENGTH/HEIGHT (mm)
	BOW	MID/S	STRN		
PORT SIDE	80%	85%	90%	C	12mm
STARBOARD	100%	100%	100%	C	10mm
FLATBOTTOM	90%			C	20mm
RUDDER	100%			C	85mm
GRATING	100%			C	ropes
PROPERLLER	100%			C	Fishing nets

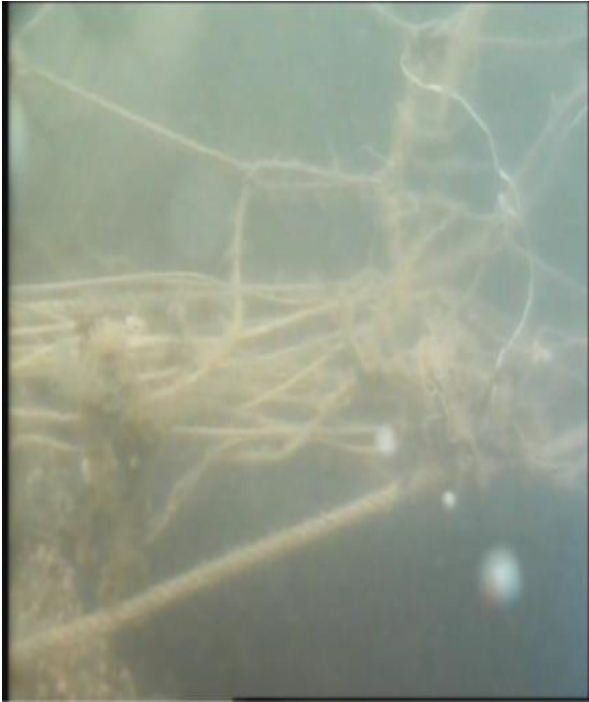
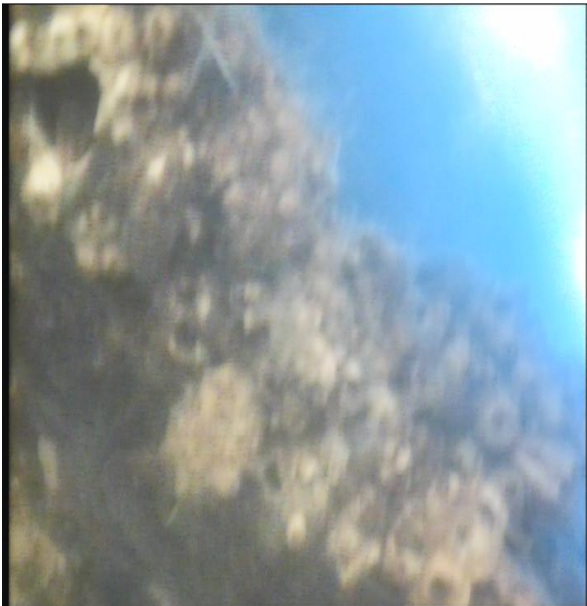
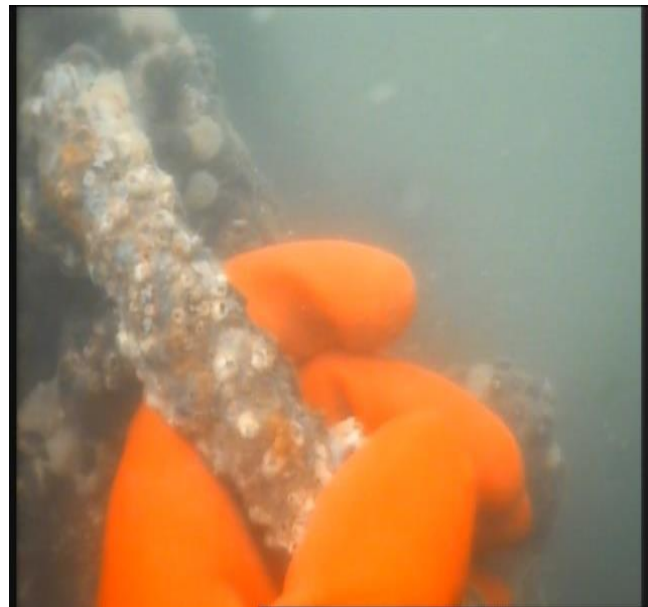
The first wreck-ship which is beneath the sea-bed cannot be properly evaluated because only about 10% of the hull can be seen at the sea-bed.

The second wreck-ship which is on top of the first, the hull is looking good but fully covered with hard marine growth, fishing nets and mooring ropes. The port side of the wreck-ship is on-top of the first wreck approximately 60%.

6) SALVAGE POSIBILITY: There are possibility to salvage the wreck-ship by cutting the wreck with under-water cutting equipment using divers in other to reduce the wreck to a smaller size of which lifting bags will be use to float it and tug to shore with a small boat.

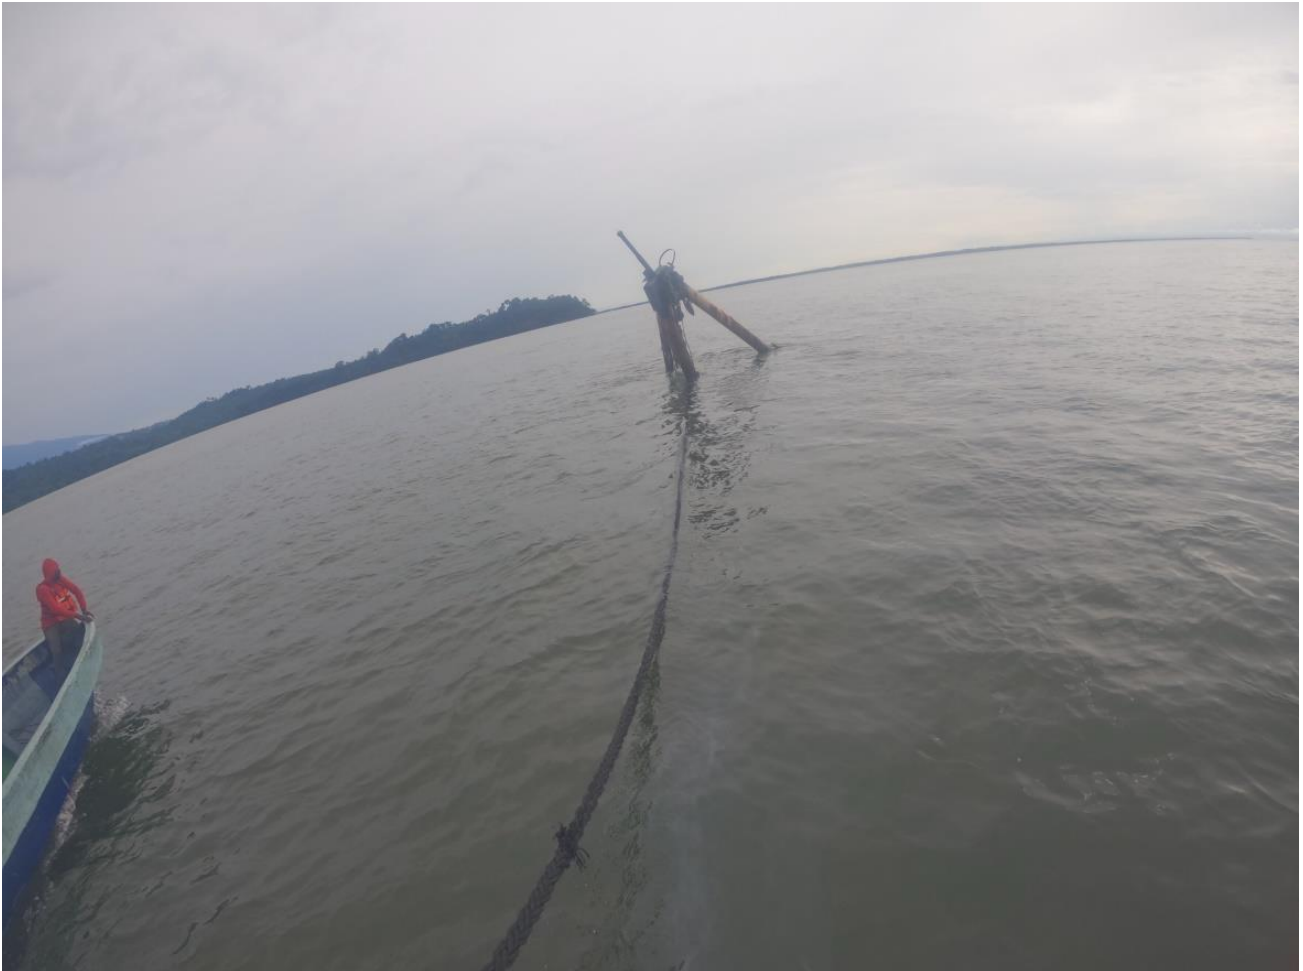
**LOCATION: DIRECTELY AT THE ENTRANCE TO TIKO PORT**  
**DATE: 06/10/23**

**THIS WAS A FISHINING TRAWLER THAT WAS CONVERTED IN TO A CARGO  
VESSEL.**

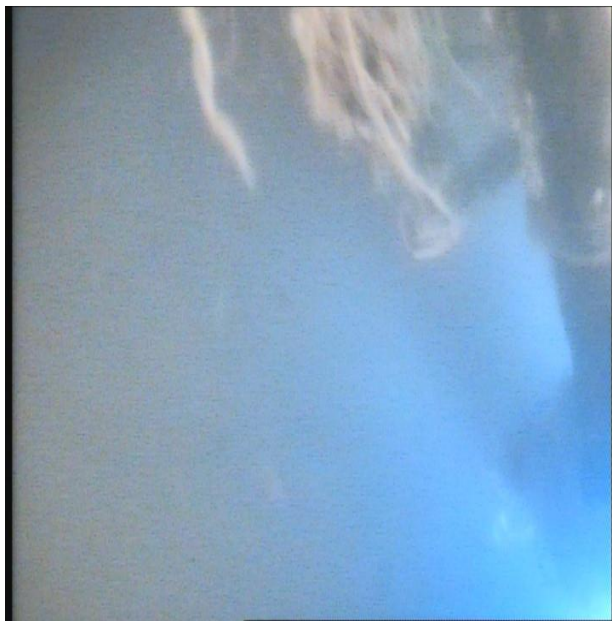
- 1) DEPTH OF THE AREA: 06.5M when low tide and 0.9m when high tide.
- 2) COORDINATE OF WRECK-SHIPS: 03\*36.512N / 009\*15.313E.
- 3) CONDITION OF WRECK-SHIPS: The third wreck-ship which is sunk about 75% beneath the seabed and 25% which is the bow is above the sea-berth. The part of the wreck-ship which is above the sea-bed still looks good (the steel) but fully covered with hard marine growth, fishing nets and mooring ropes. The port side of the wreck right up to the stern is approximately 75% is beneath the sea bed.
- 4) CONDITION OF THE SEA-BED: The sea-berth has very soft mud.
- 5) DISTANCE FROM THE WRECK-SHIP TO SHORE: Is 0.9NM.
- 6) SALVAGE POSSIBILITY: There is possibility to salvage the wreck-ship by cutting the small part of the wreck approximately 25% of wreck-ship which is above the sea-bed with under-water cutting equipment (BROCO) to free the entrance of Tiko port.
